Manhole Inspection Summary

Manhole # S11CC2007MH

Insp Date: **9/26/06 3:30 PM**

Location Address: **5804 DALE RD**

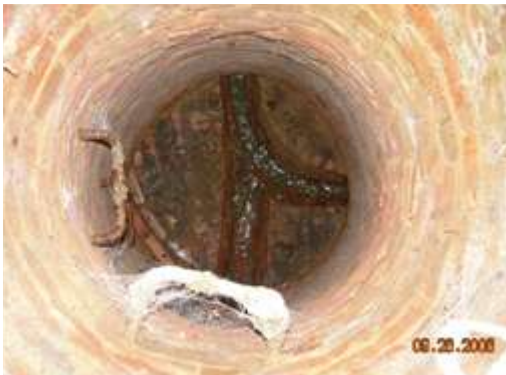
Top View

☒ **Debris** (not Condition related)

☒ **Corroded**

☒ **Evidence Of Surcharge**

Evidence of surcharge - Bench debris.
Corroded steps.

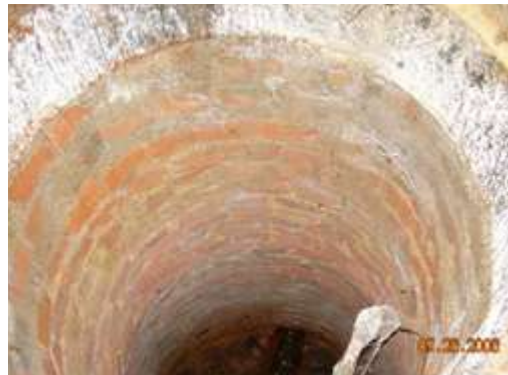
Defect

☒ **Leaks**

Infiltration: ☐ None ☒ **Joint** ☐ Cracks ☒ **Mortar** ☐ Roots ☐ Wall

Infiltration: ☐ None ☐ Joint ☐ Cracks ☒ **Mortar** ☐ Roots ☒ **Wall**

Frame leaks. Adjustment and Corbel
infiltration.

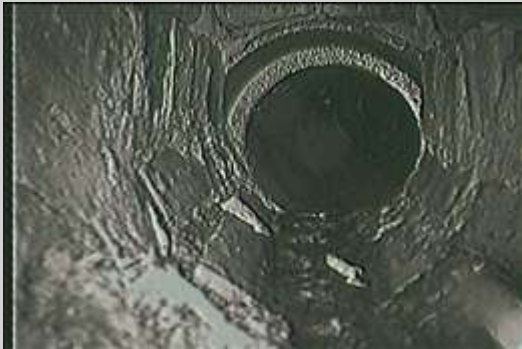
8 in. Circular Gravity Sewer Pipe Out @ 12 O'Clock

Comments **The I3 pipe picture shows Channel deterioration. The O12 pipe seal is not flush to the pipe.**

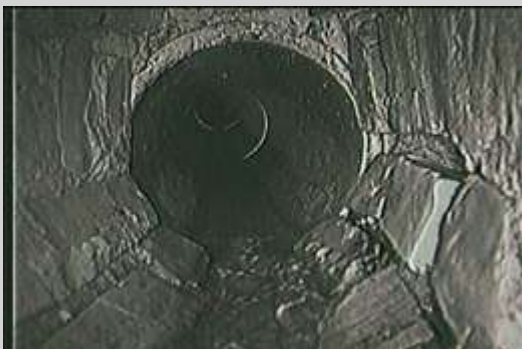
8 in. Circular Gravity Sewer Pipe In @ 3 O'Clock

Condition: ☐ Sound ☐ Cracked ☐ Root Intrusion ☒ **Deteriorated** ☐ Leaks ☐ Debris

Channel deterioration.

Infiltration: **Evidence** Pipe Seal Cond: **Cracked**

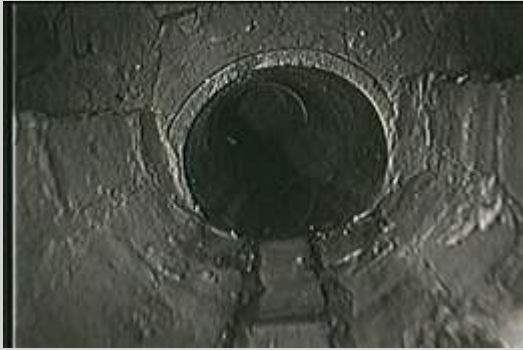
Pipe In @ 6 O'Clock

Infiltration: **Evidence** Pipe Seal Cond: **Unknown**
